November 7, 2023

FILE NO.: 306369-001

**PROJECT:** INDEPENDENCE RANCH COMMUNITY SERVICES DISTRICT  
VARIOUS STREETS  
SAN MIGUEL, CALIFORNIA

**SUBJECT:** Report of Existing Pavement Conditions and Recommendations for Future Roadway Rehabilitation

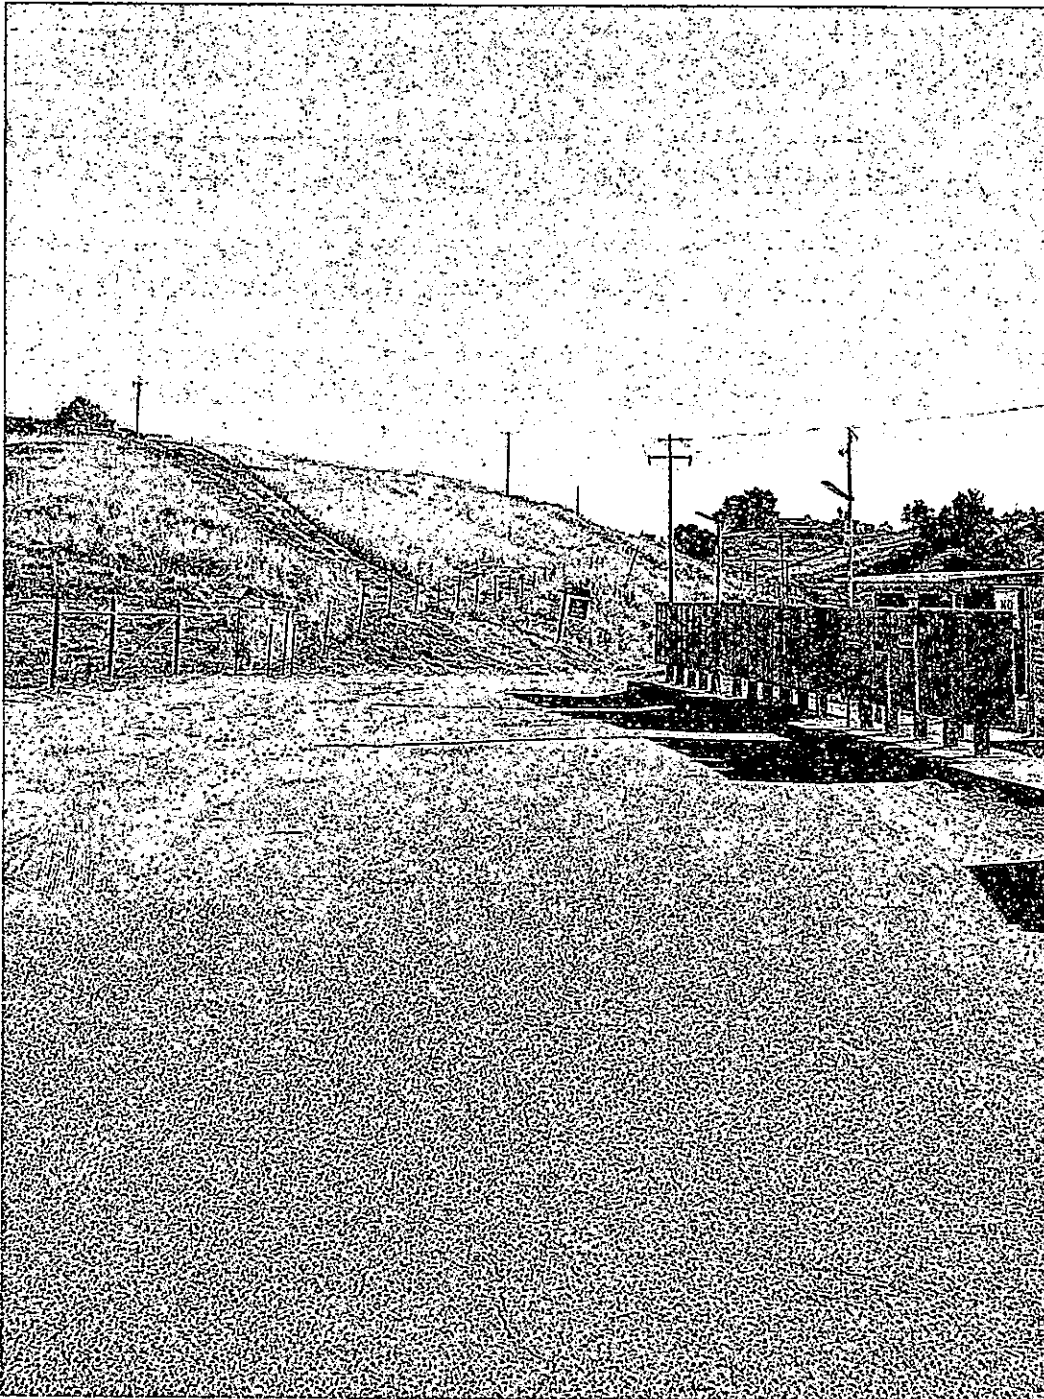
*Photo 1: Mailboxes at Entrance to Independence Ranch CSD, Partial Chip Seal and Minor Block Cracking*

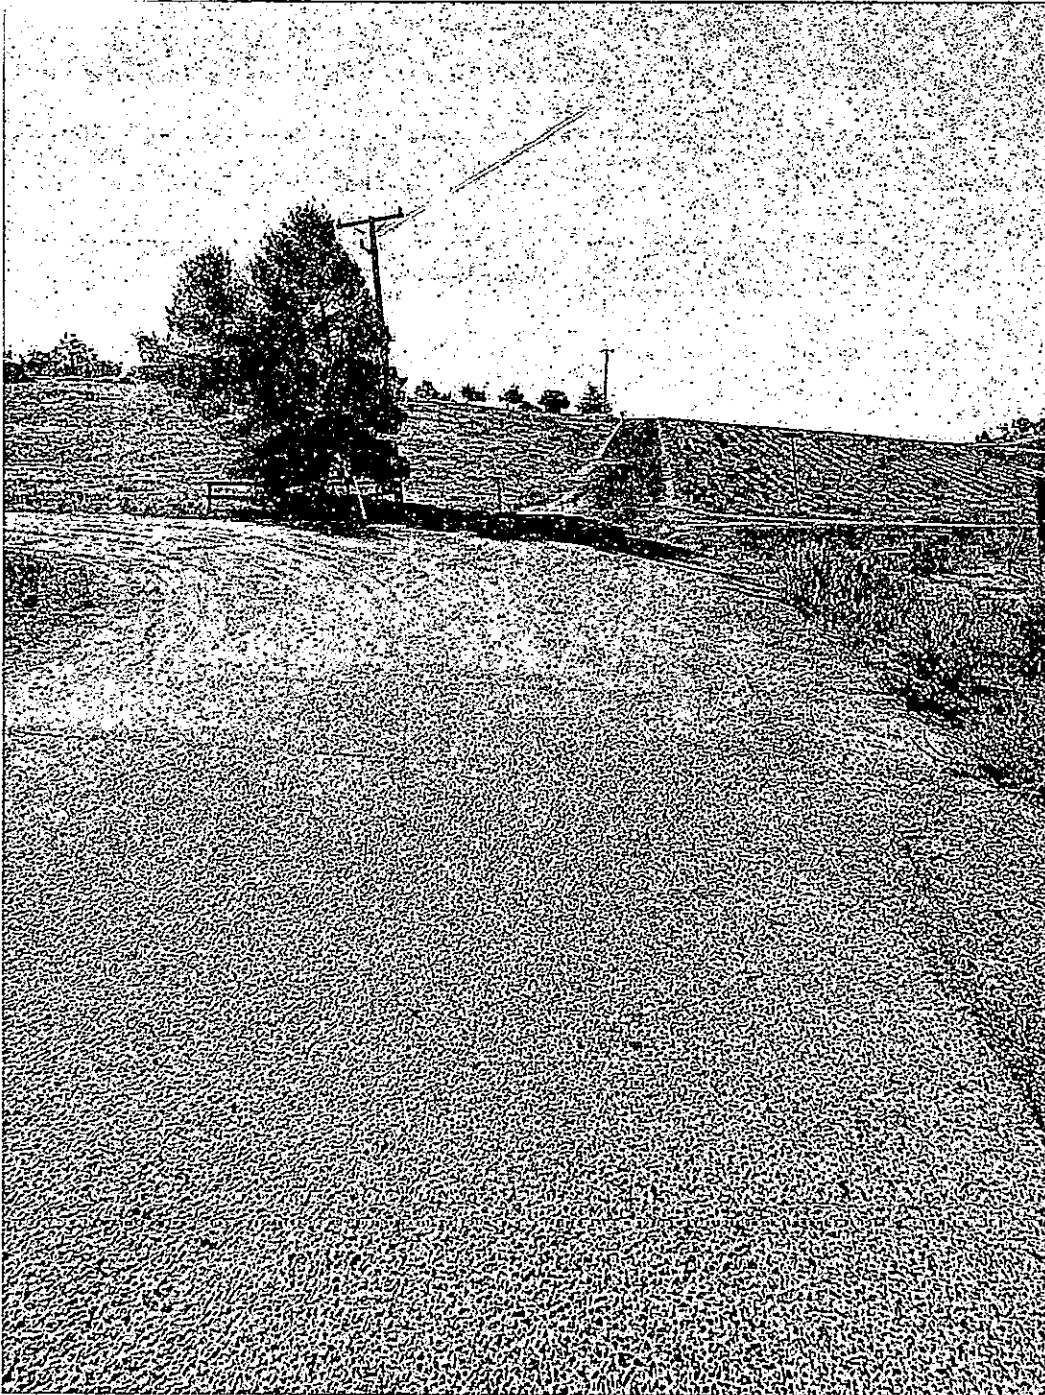
*Photo 2: Intersection of Gray Hawk Way and Lazy Hill Road, Chip Seal and Apparent Drainage Issues During Winter Storms*

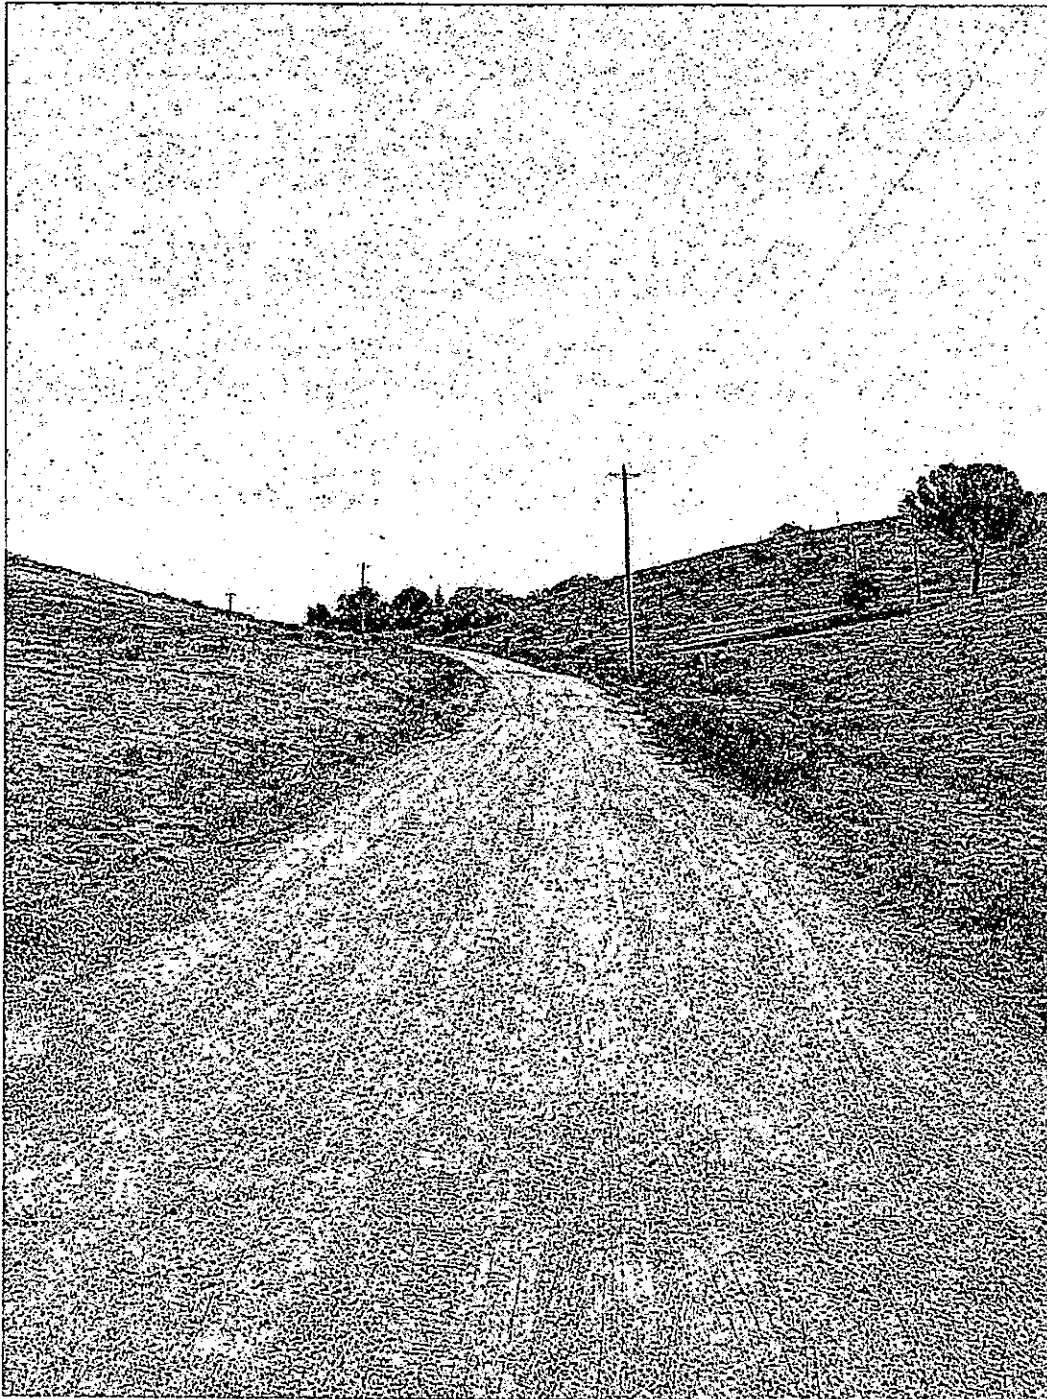
*Photo 3: Lazy Hill Road, Rutting in Gravel*

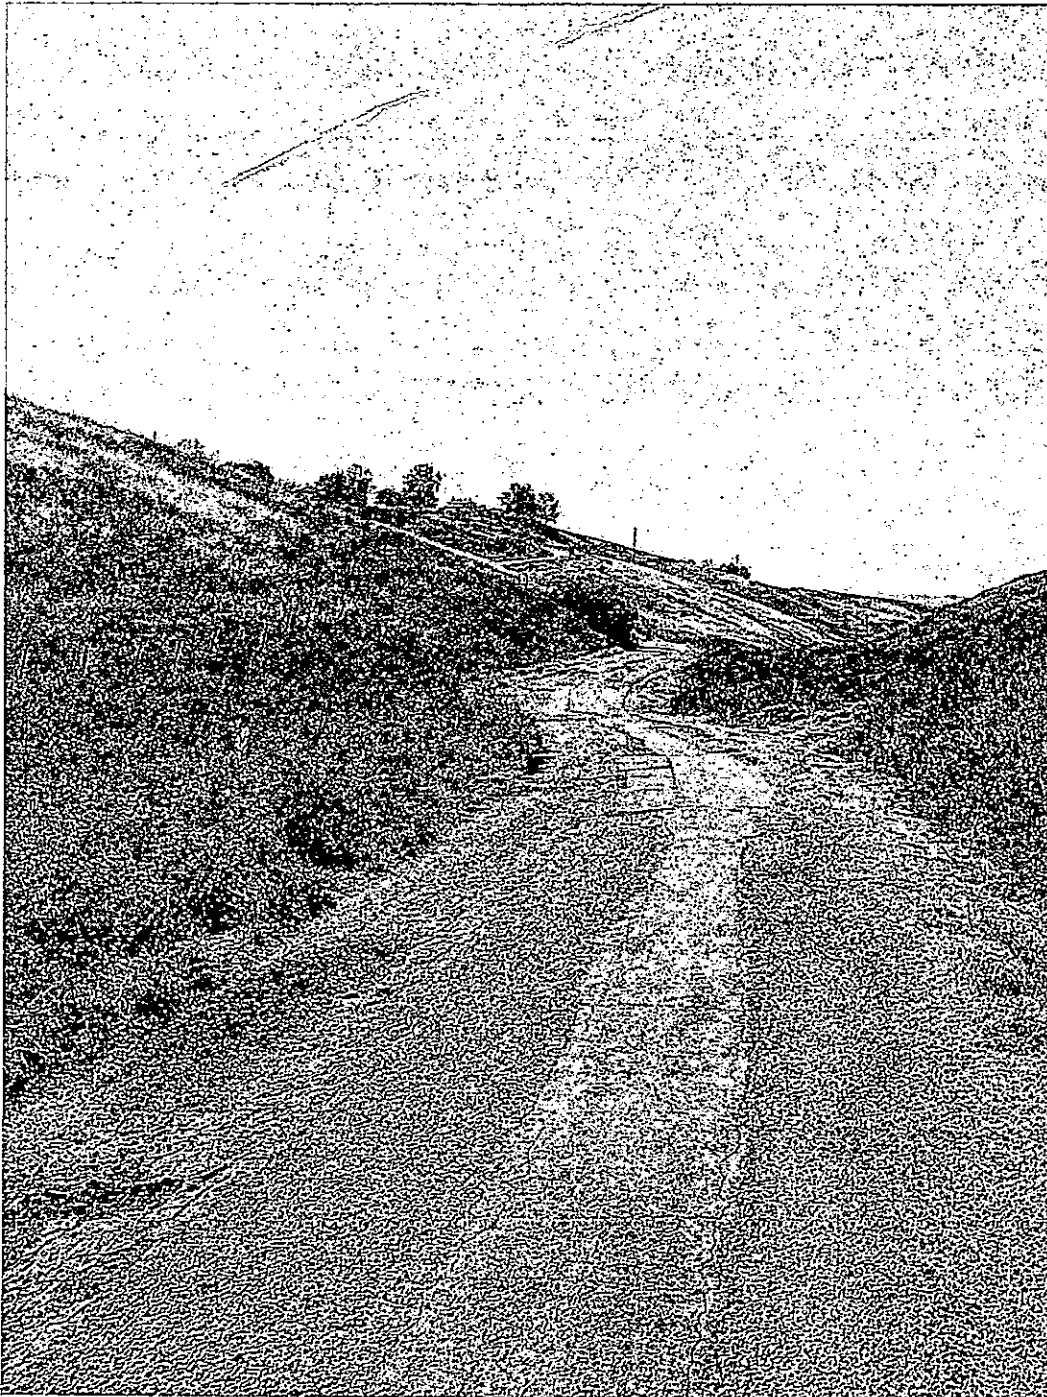
*Photo 4: Bald Eagle, Patch Deterioration and Edge Potholes*

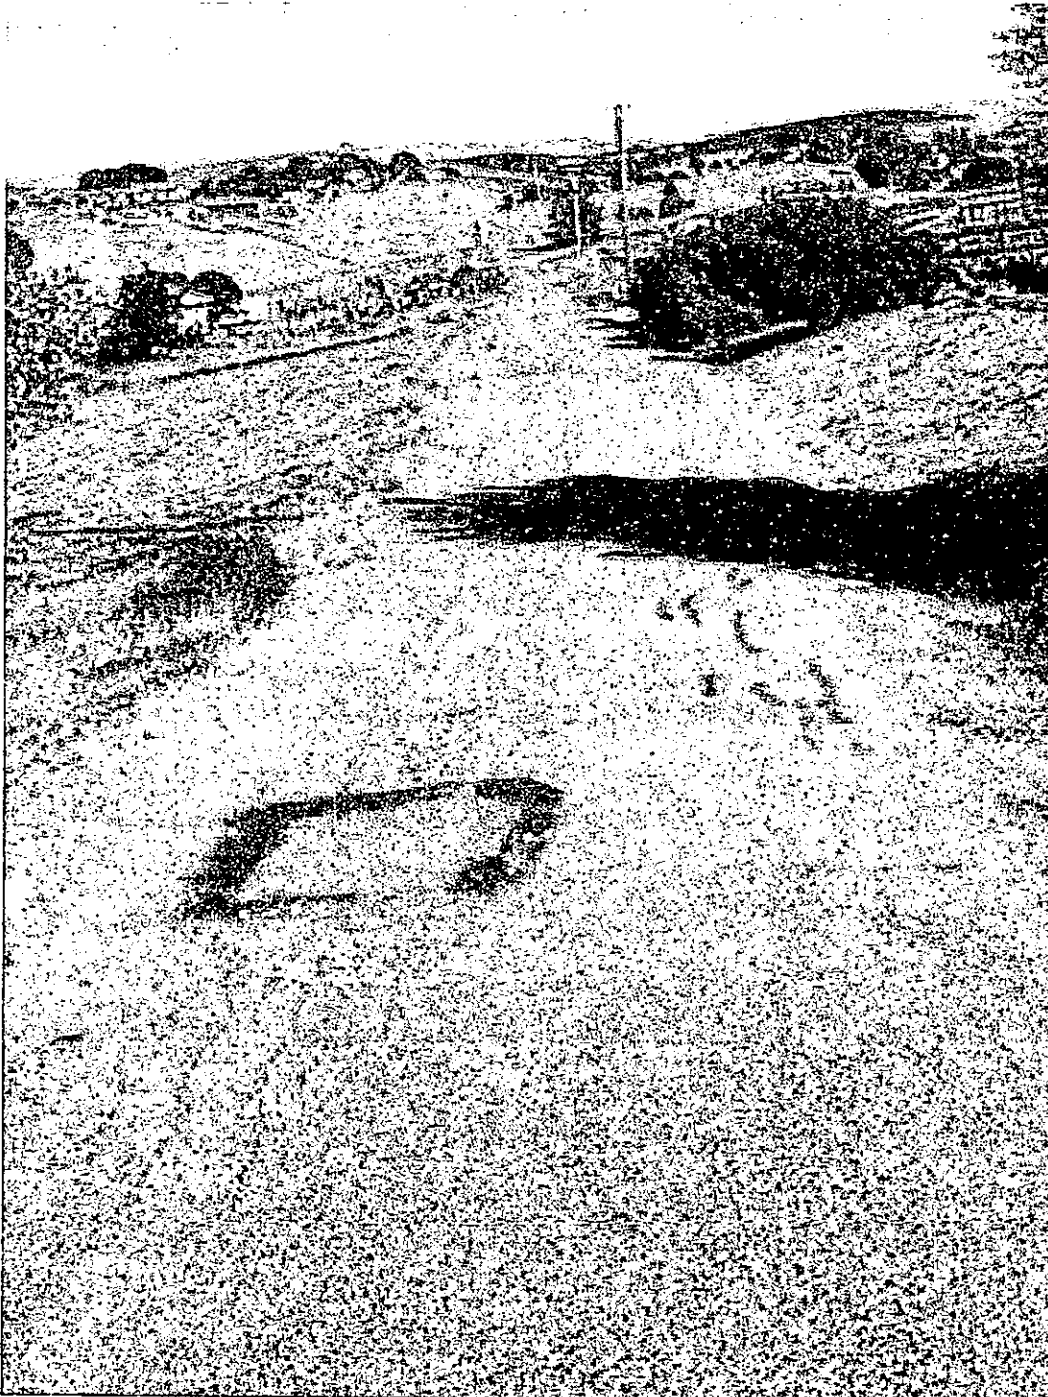
*Photo 5: Gray Hawk Way, Pothole Patch and Crack Sealing with Cracking within Wheel Path*

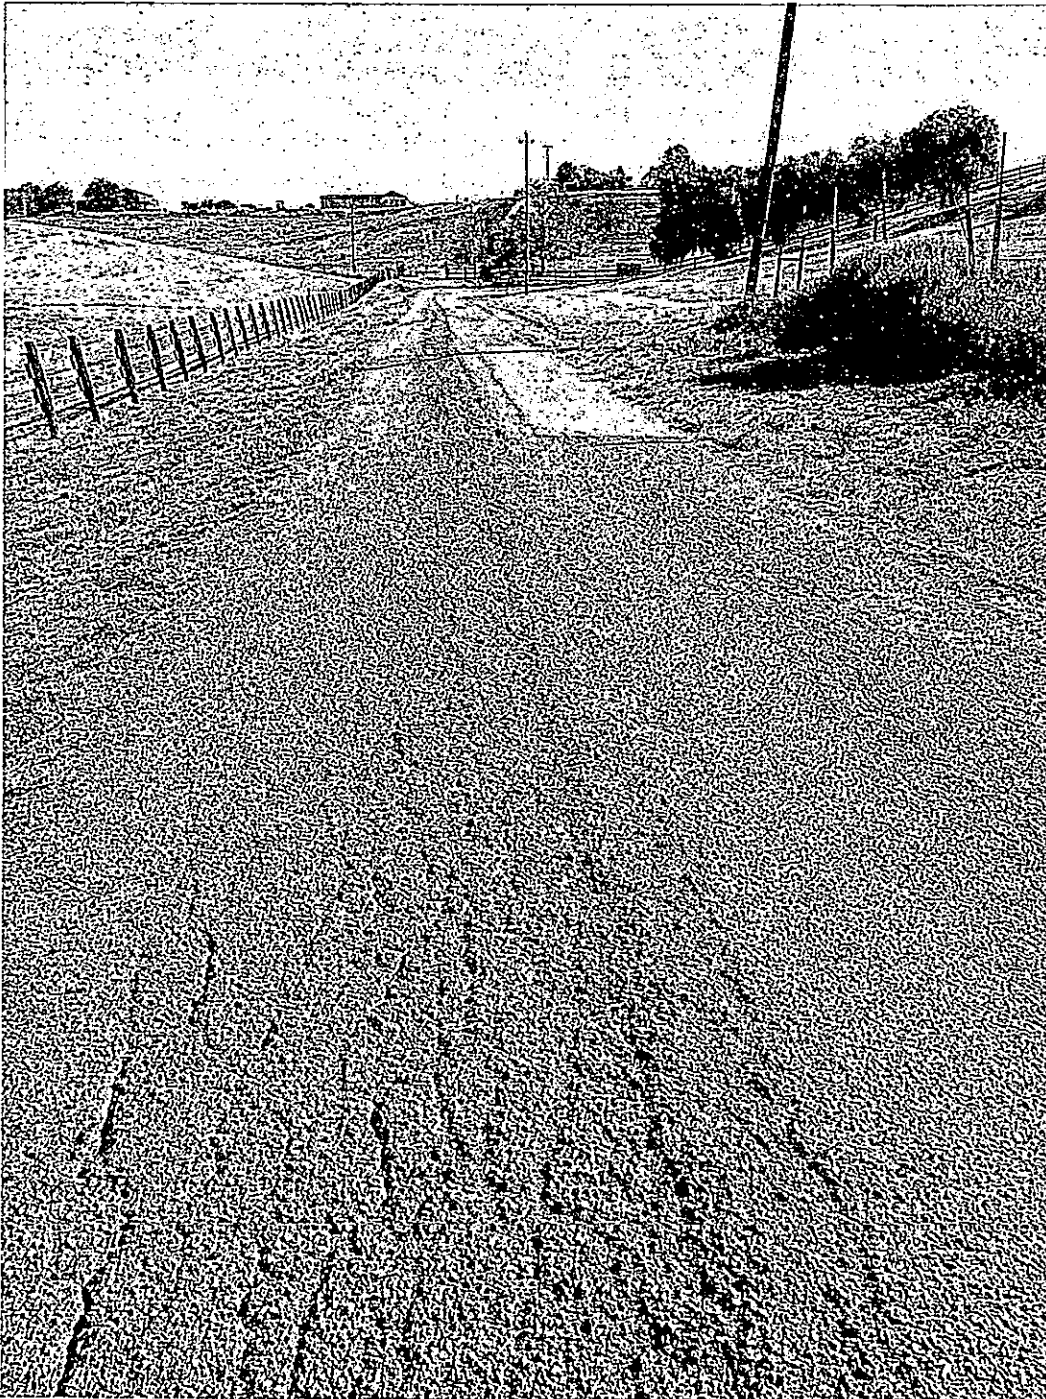
*Photo 6: Independence Ranch Place, Cracking within Wheel Path and Pothole Patch*

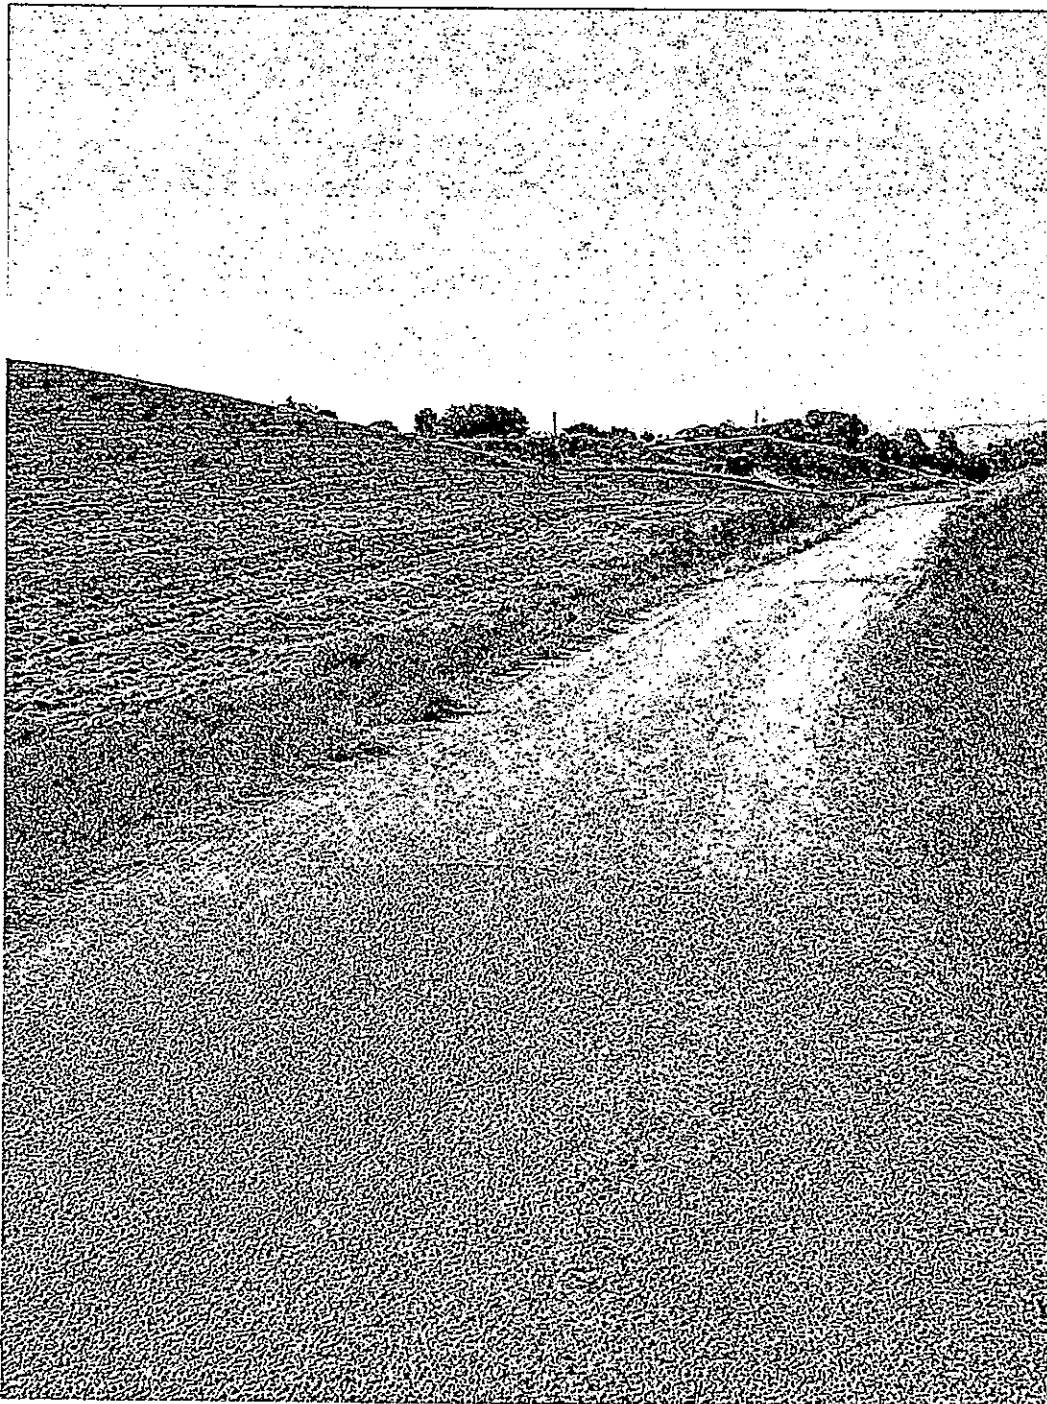
*Photo 7: Ojas Azules Place, Gravel/Chip Seal Boundary with Minor Rutting*

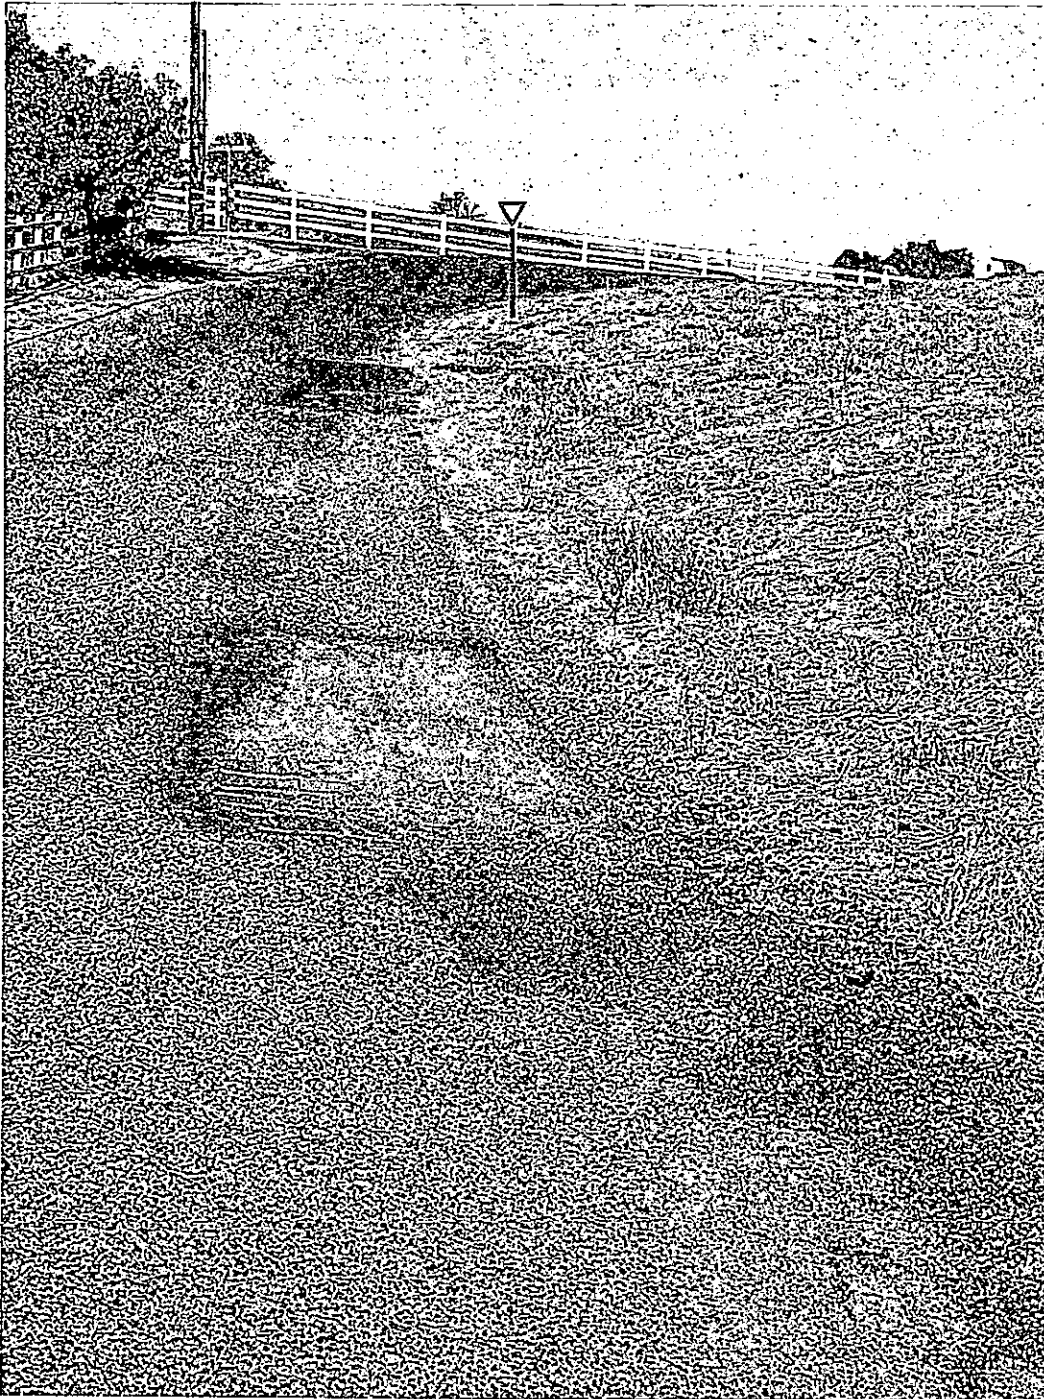
*Photo 8: Ojas Azules Place, Failed Pothole Patches*

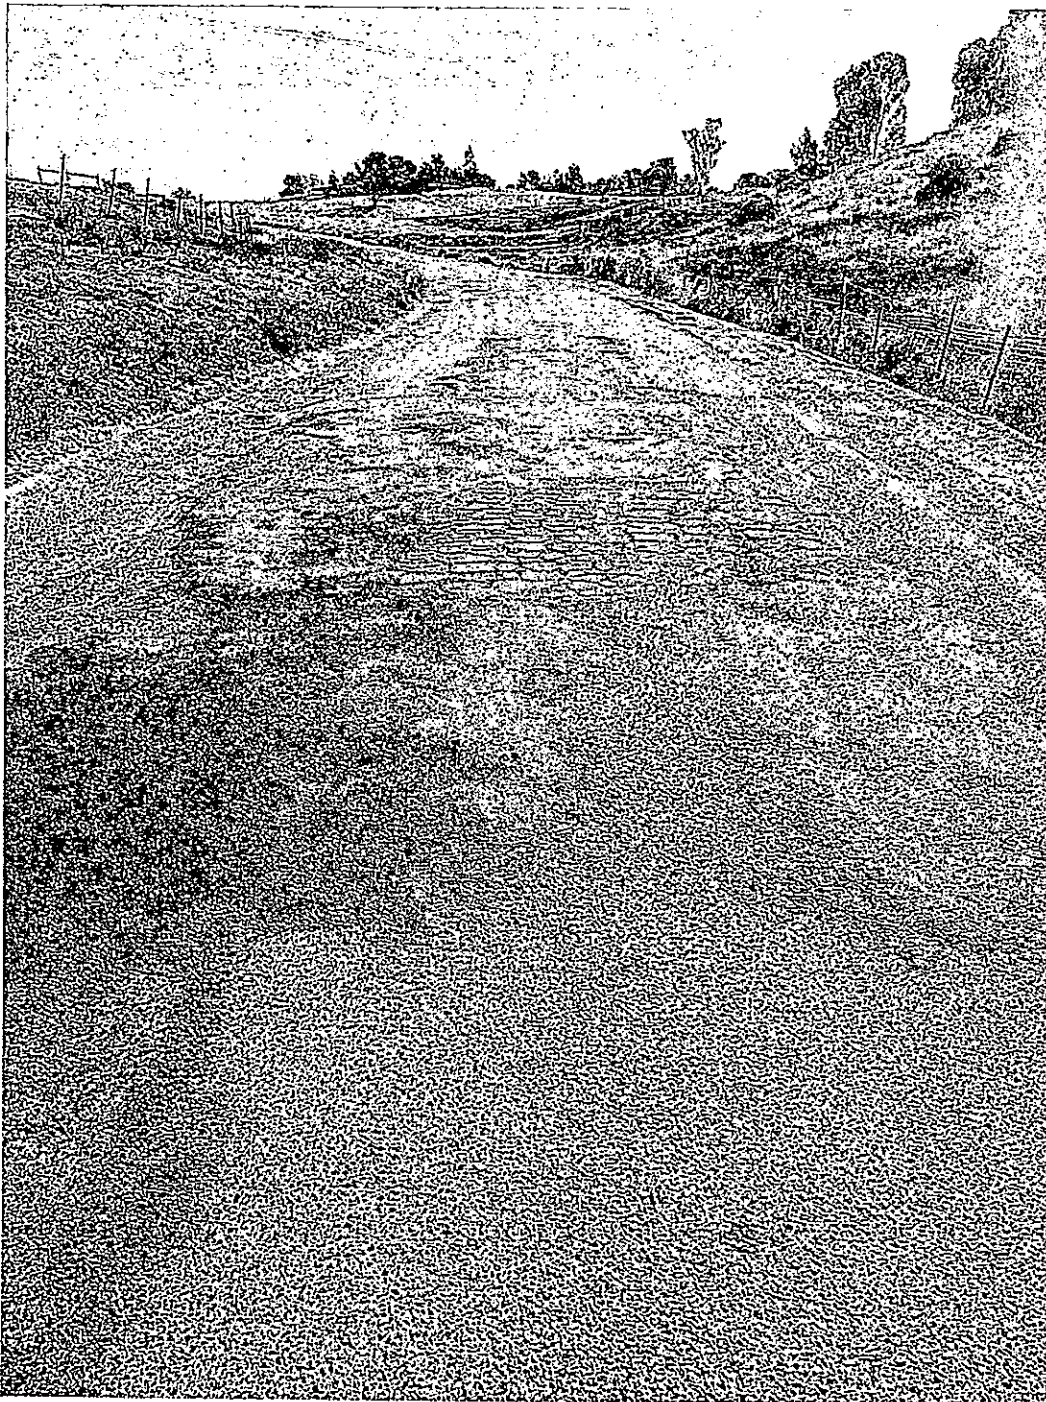
*Photo 9: Avenida Trinidad Place, Shoving within Patches and Patch Deterioration*

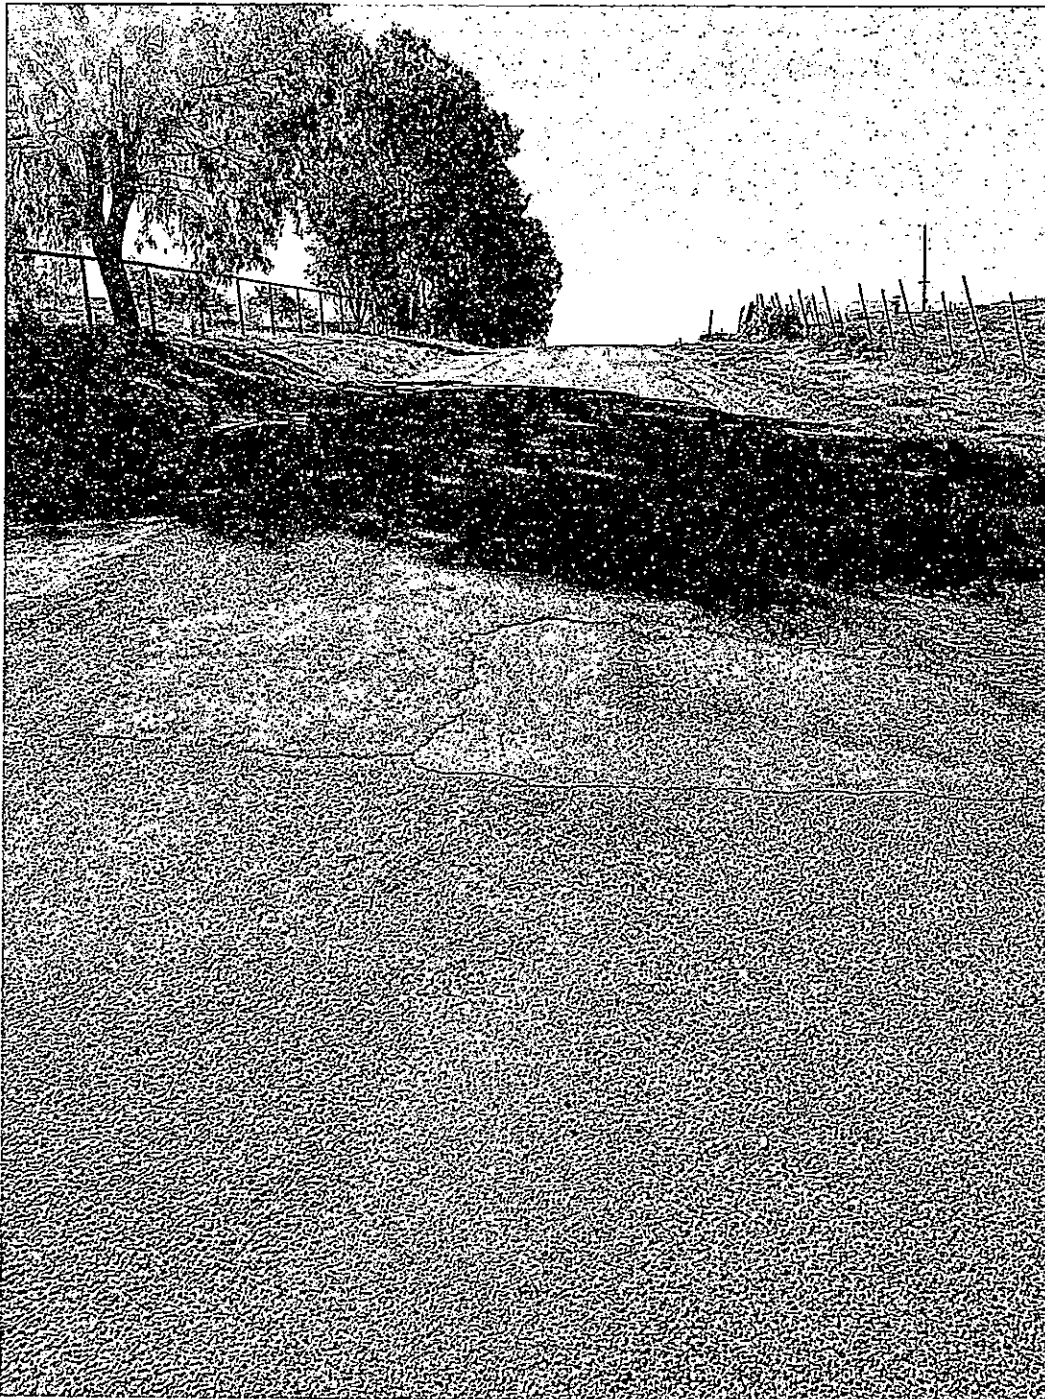
*Photo 10: Rancho Lomas Way, Chip Seal and Patch Deterioration*

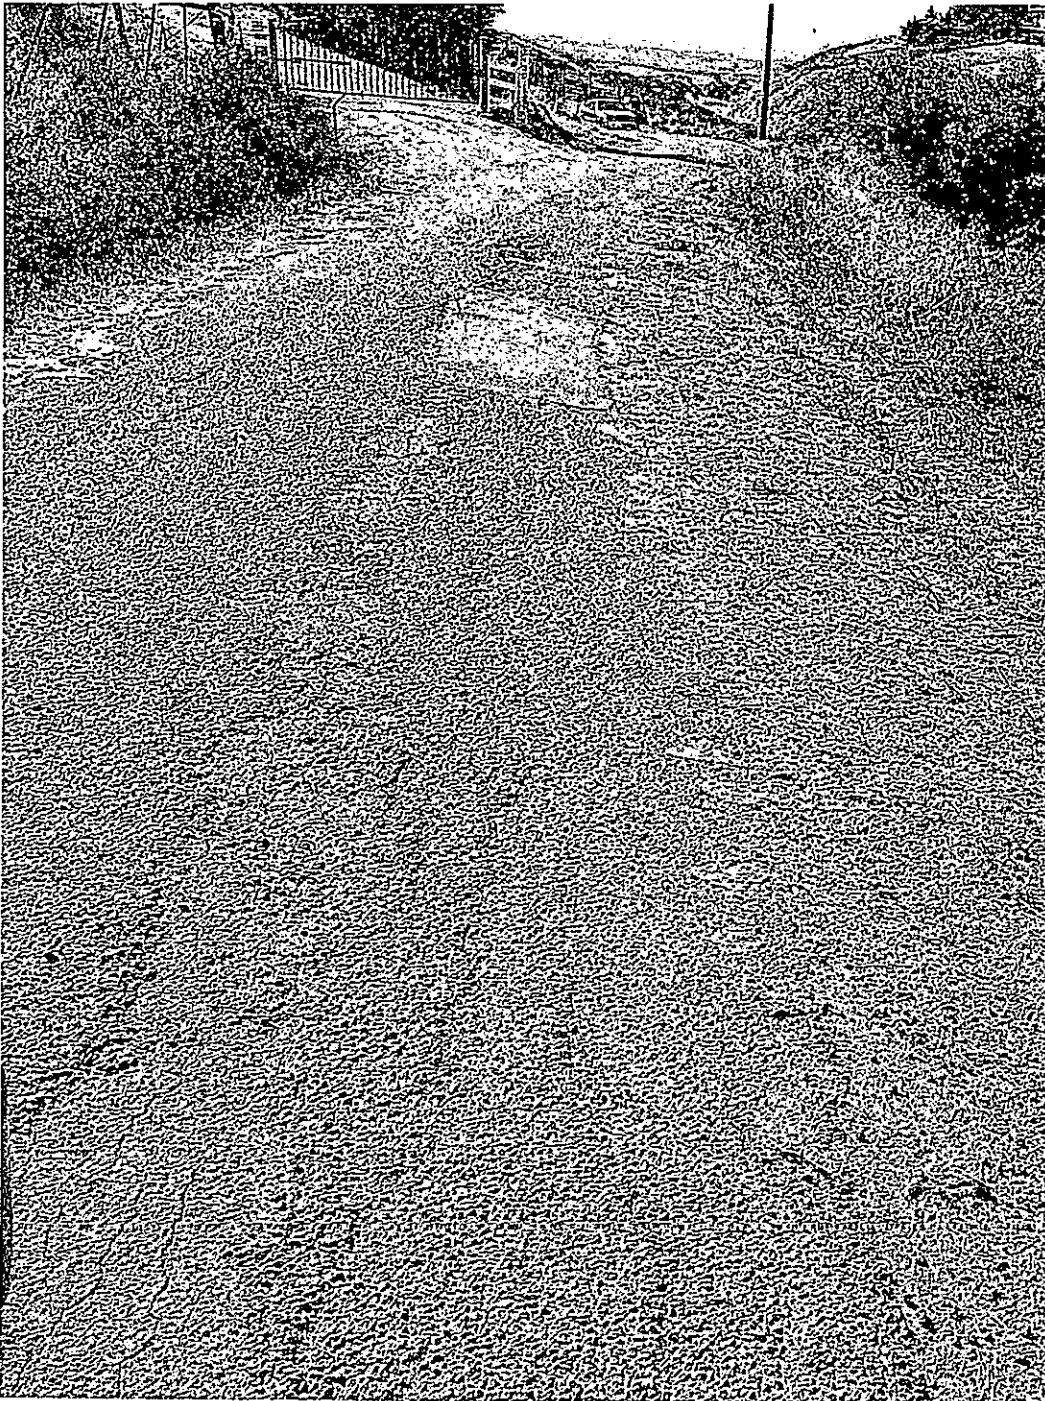
*Photo 11: Presidio Way, Chip Seal/Patch Deterioration and Cracking within Wheel Path*

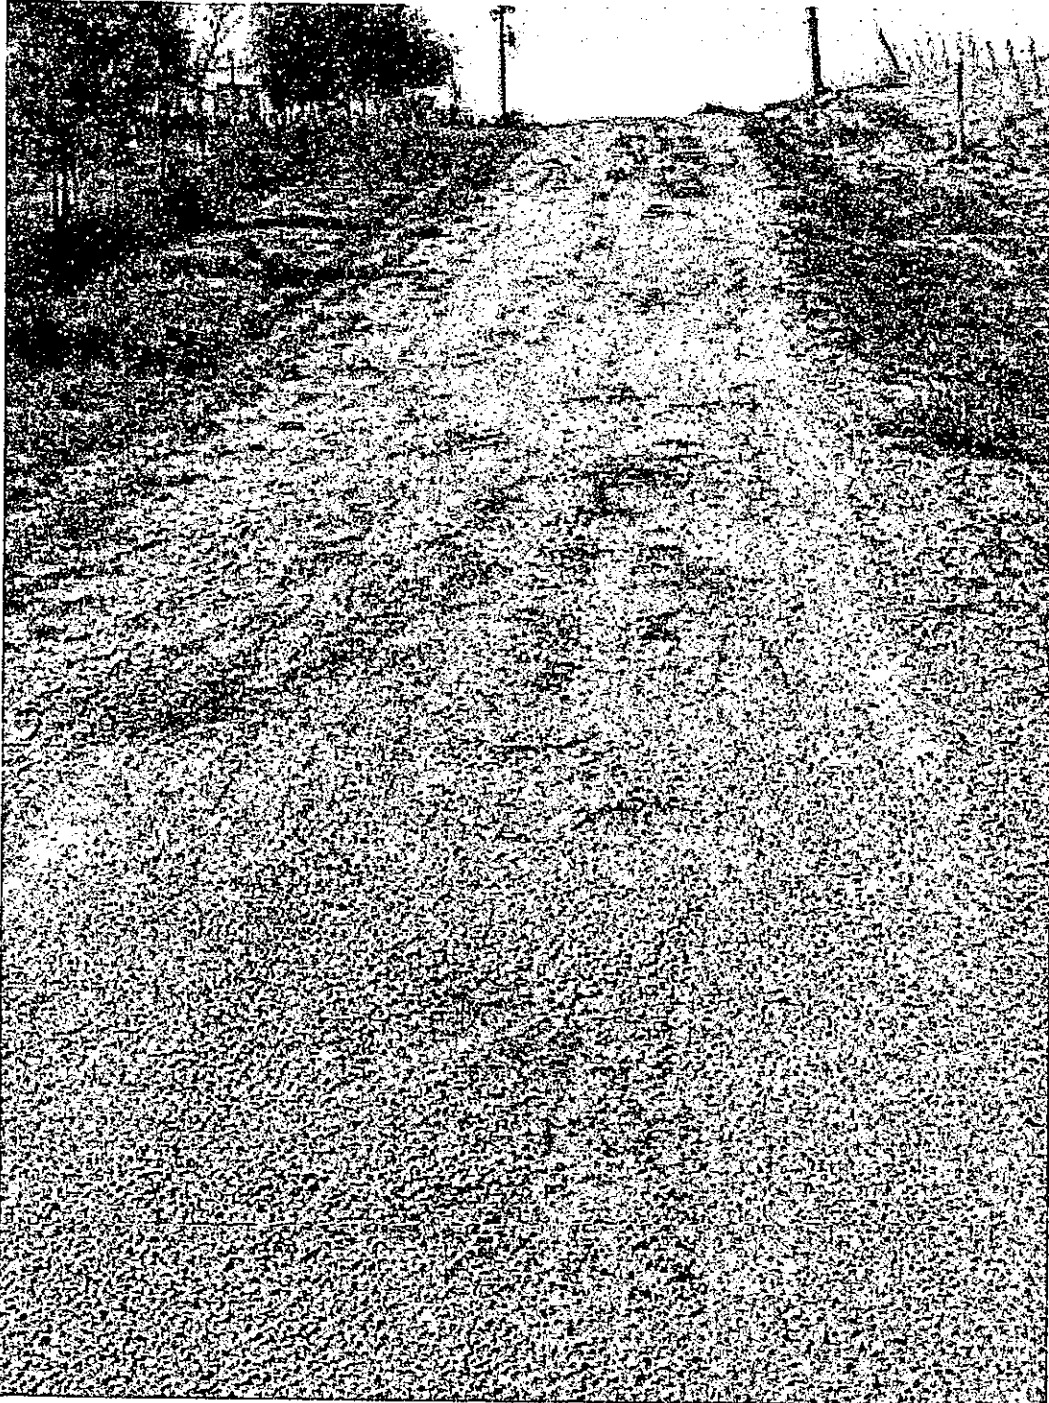
*Photo 12: Valle Miranda, Rutting and Potholes*

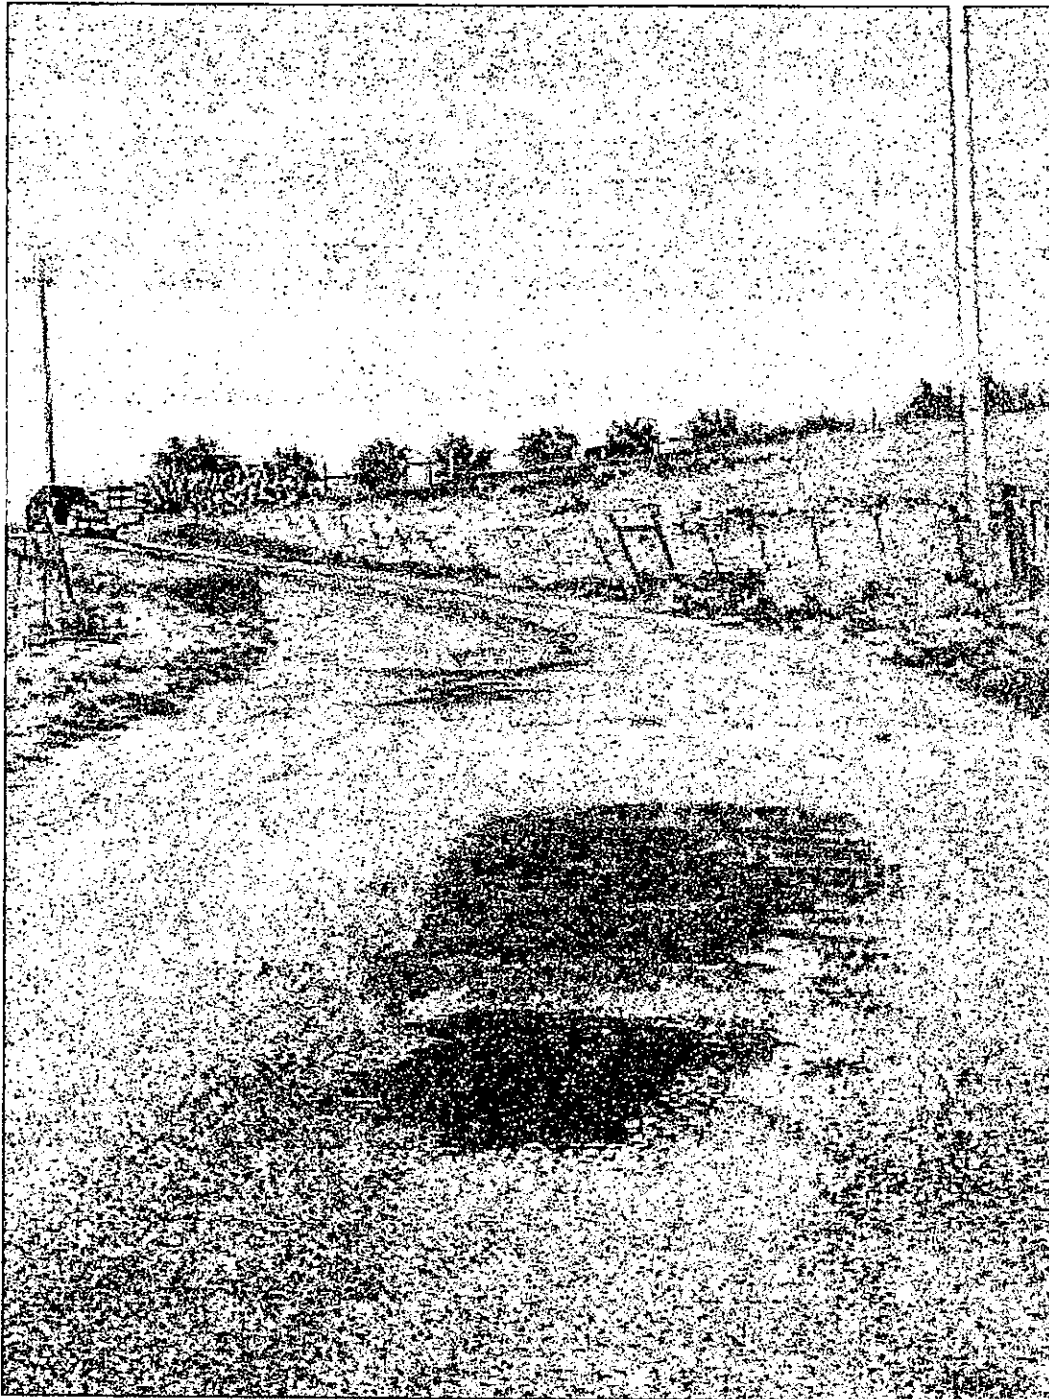
*Photo 13: Rancho Lomas Way, Patch Deterioration*

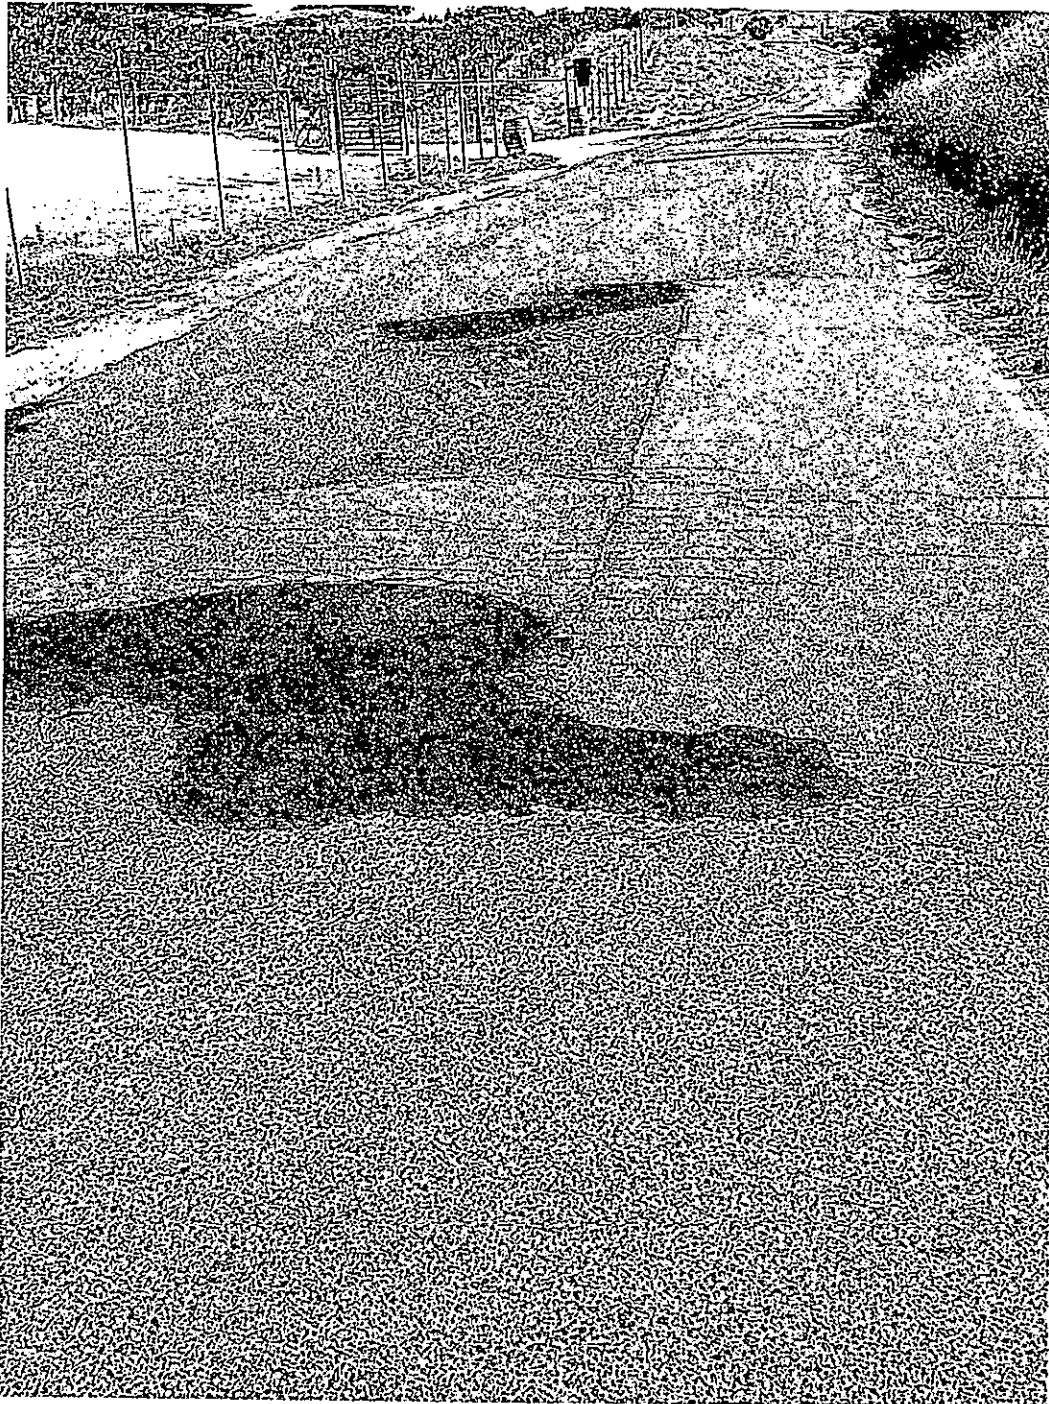
*Photo 14: Independence Ranch Place, Patch Deterioration and Cracking in Wheel Path*

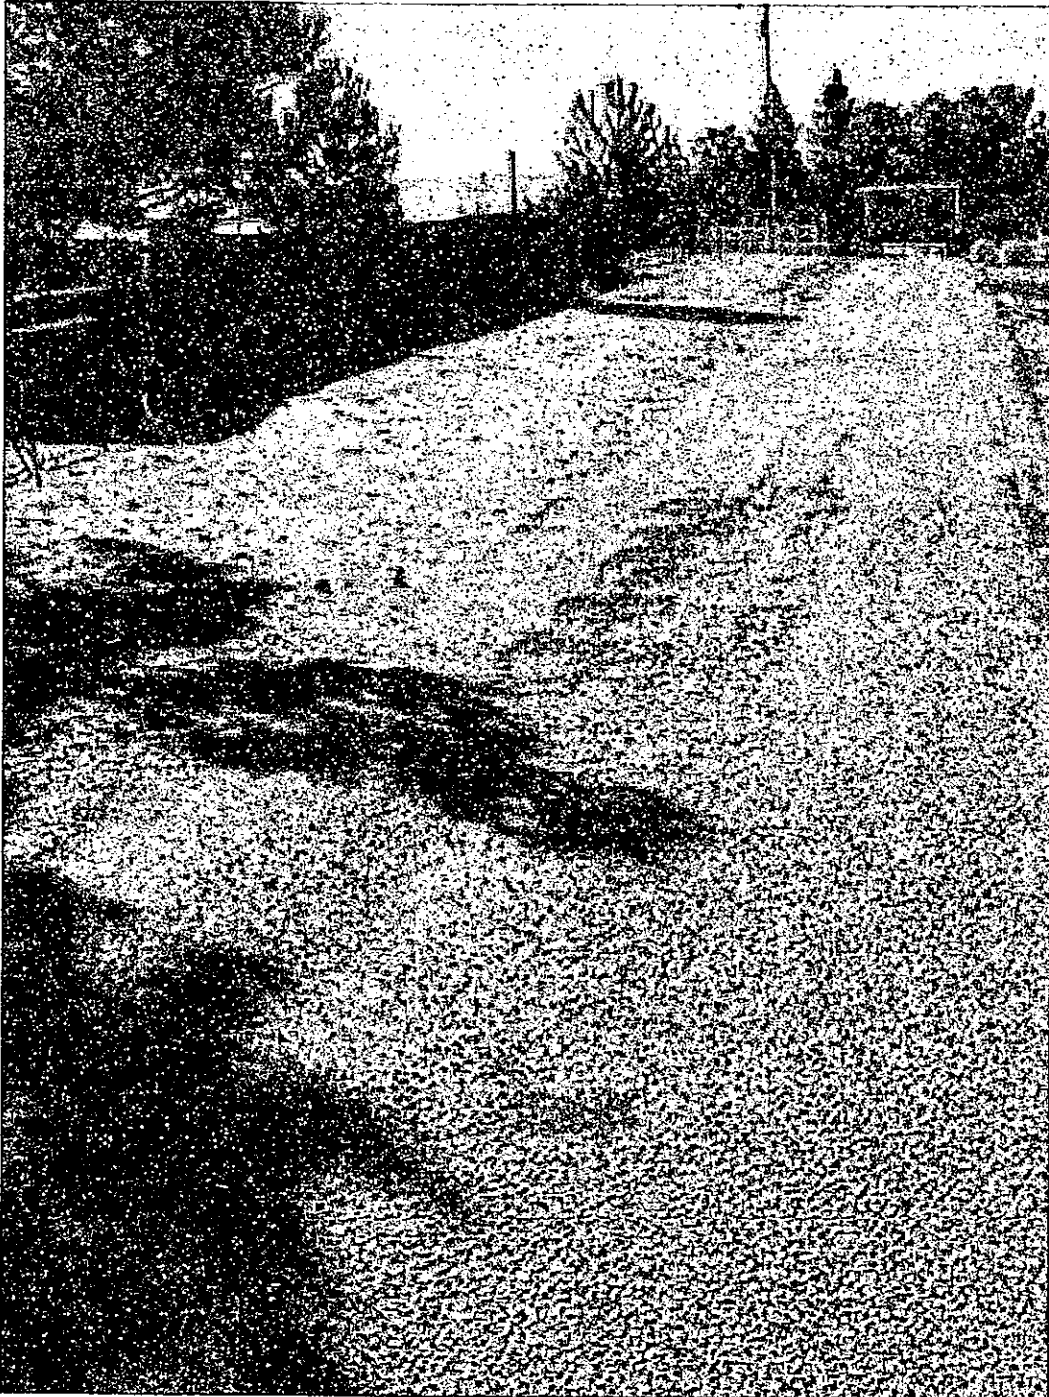
*Photo 15: Golden Eagle Way, Pothole*
