November 7, 2023

FILE NO.: 306369-001

**PROJECT:** INDEPENDENCE RANCH COMMUNITY SERVICES DISTRICT  
VARIOUS STREETS  
SAN MIGUEL, CALIFORNIA

**SUBJECT:** Report of Existing Pavement Conditions and Recommendations for Future Roadway Rehabilitation

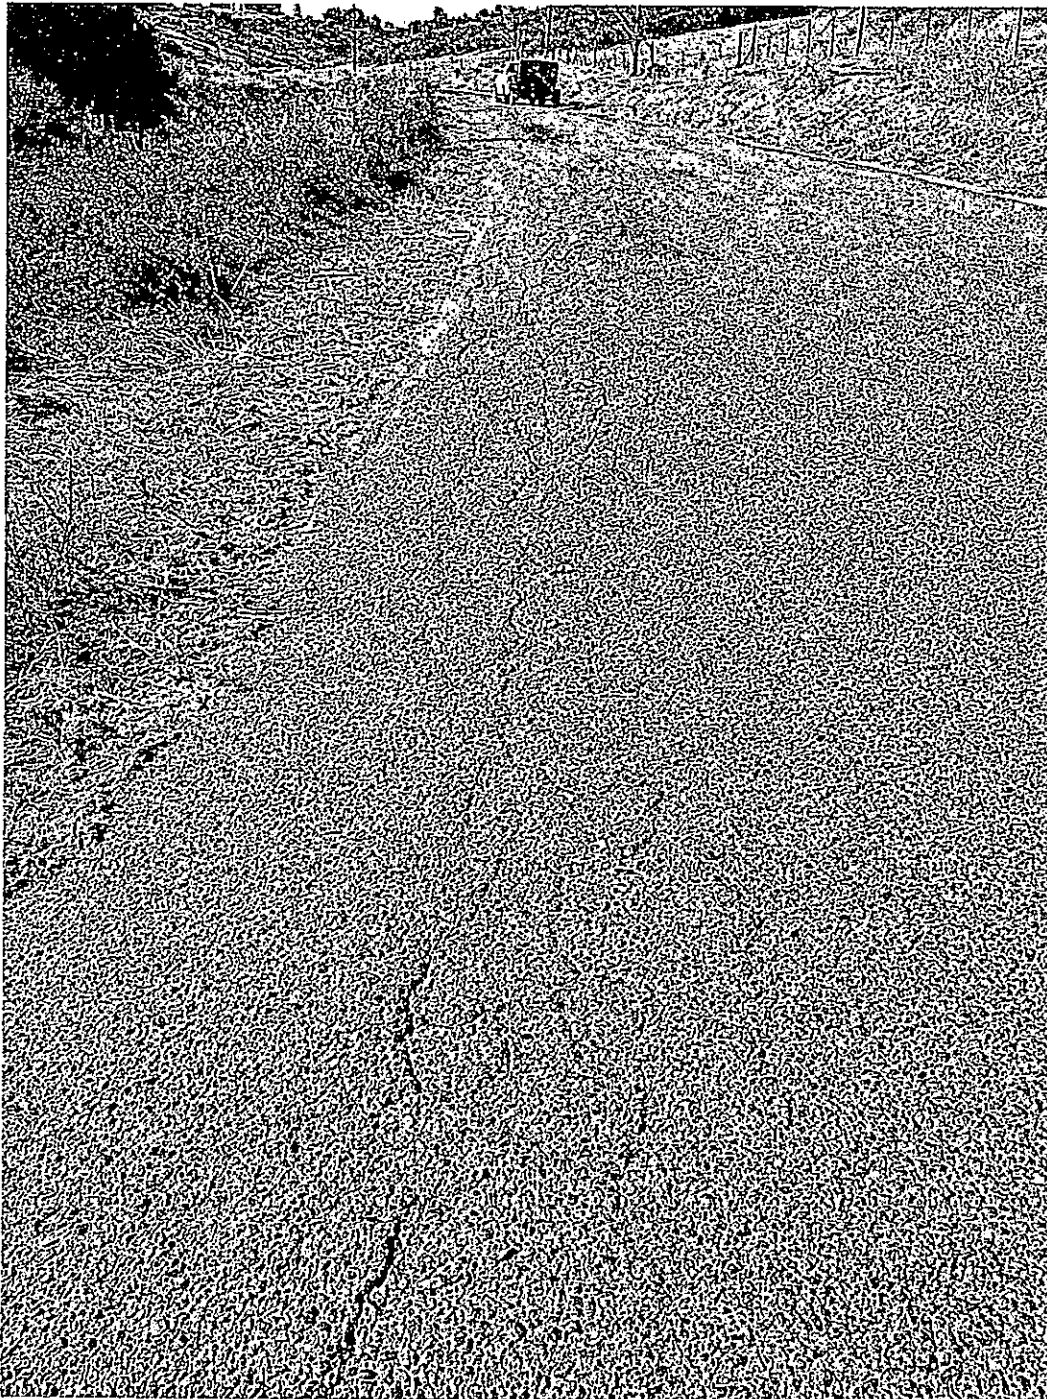
*Photo 16: Hawk Ridge Place, Longitudinal Edge Cracking and Cracking in Wheel Path*

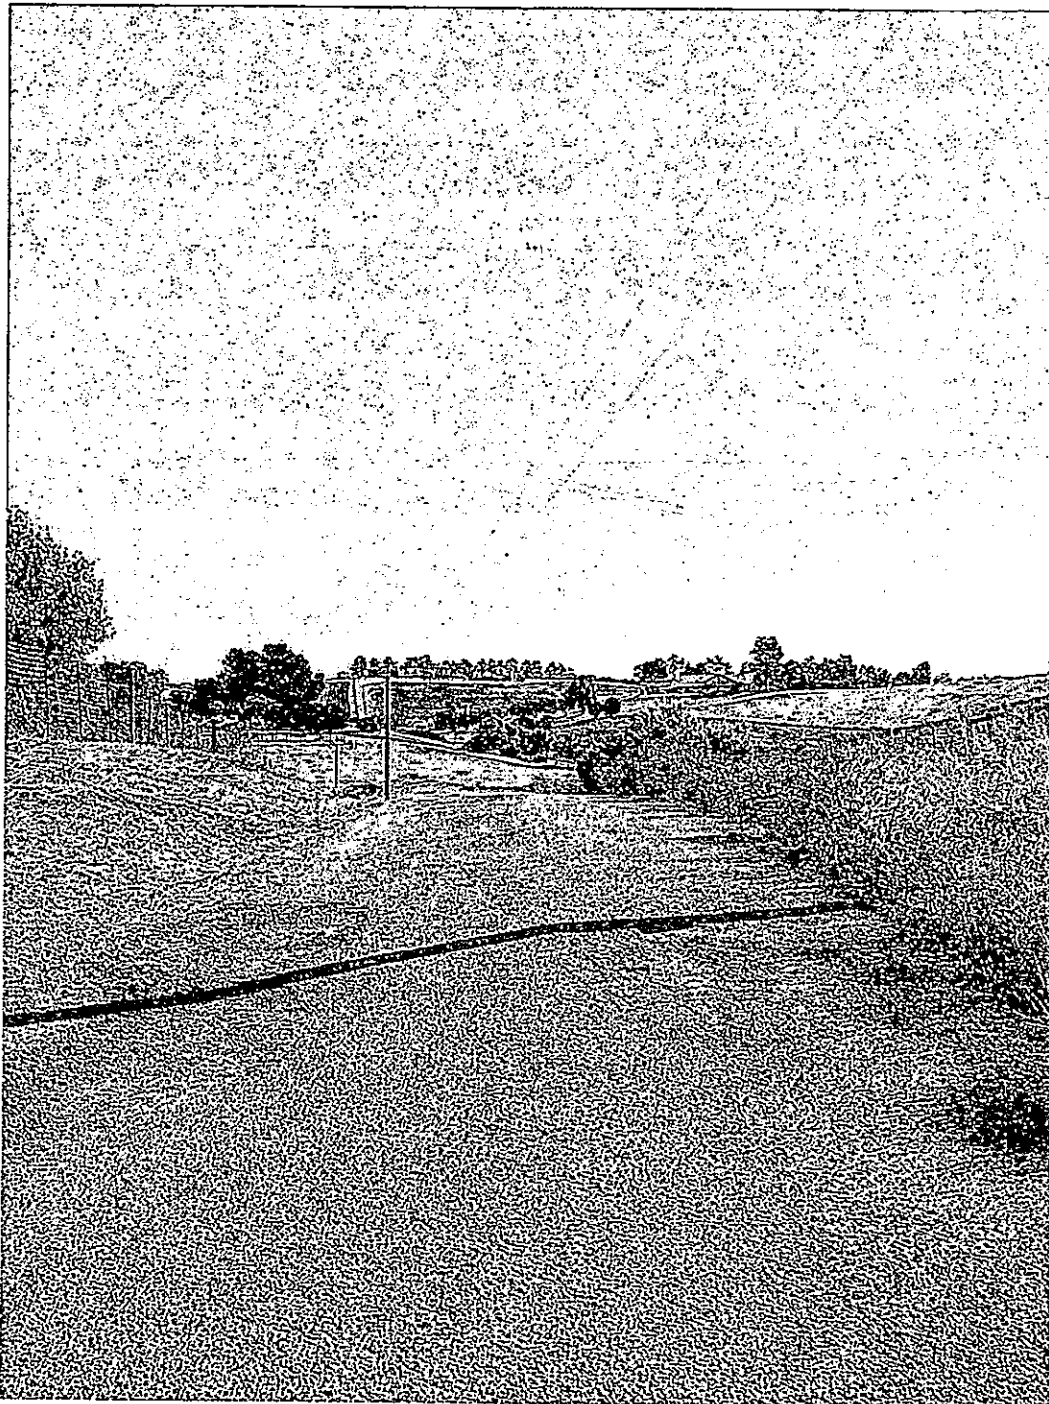
*Photo 17: Independence Ranch Place, Potholes*

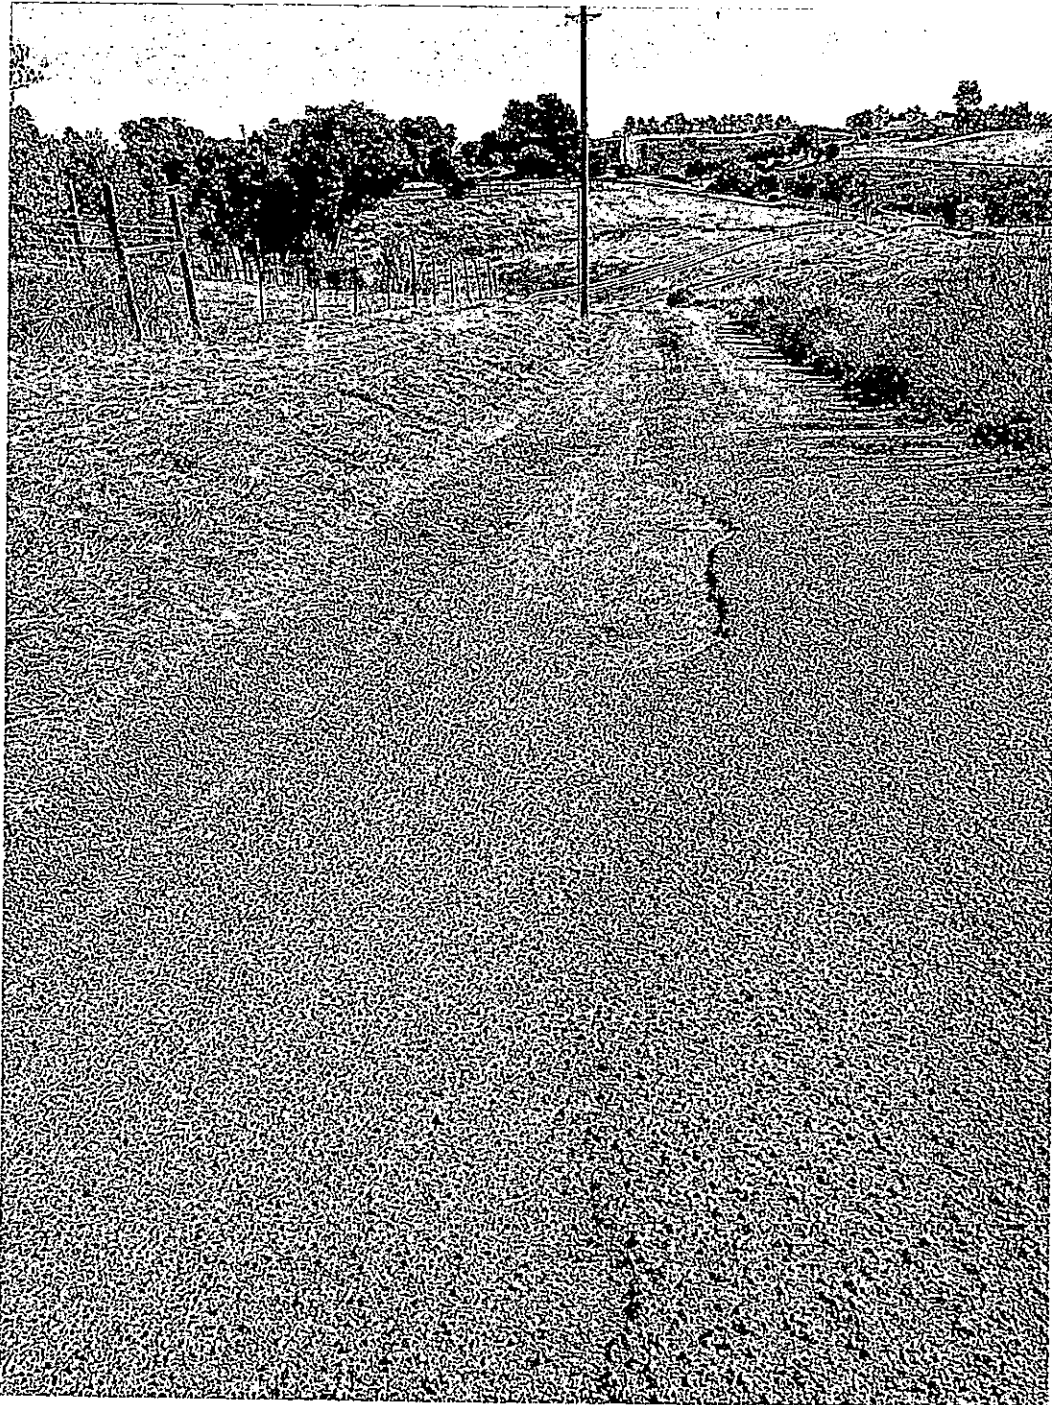
*Photo 18: Independence Ranch Place, Potholes and Chip Seal Deterioration*
